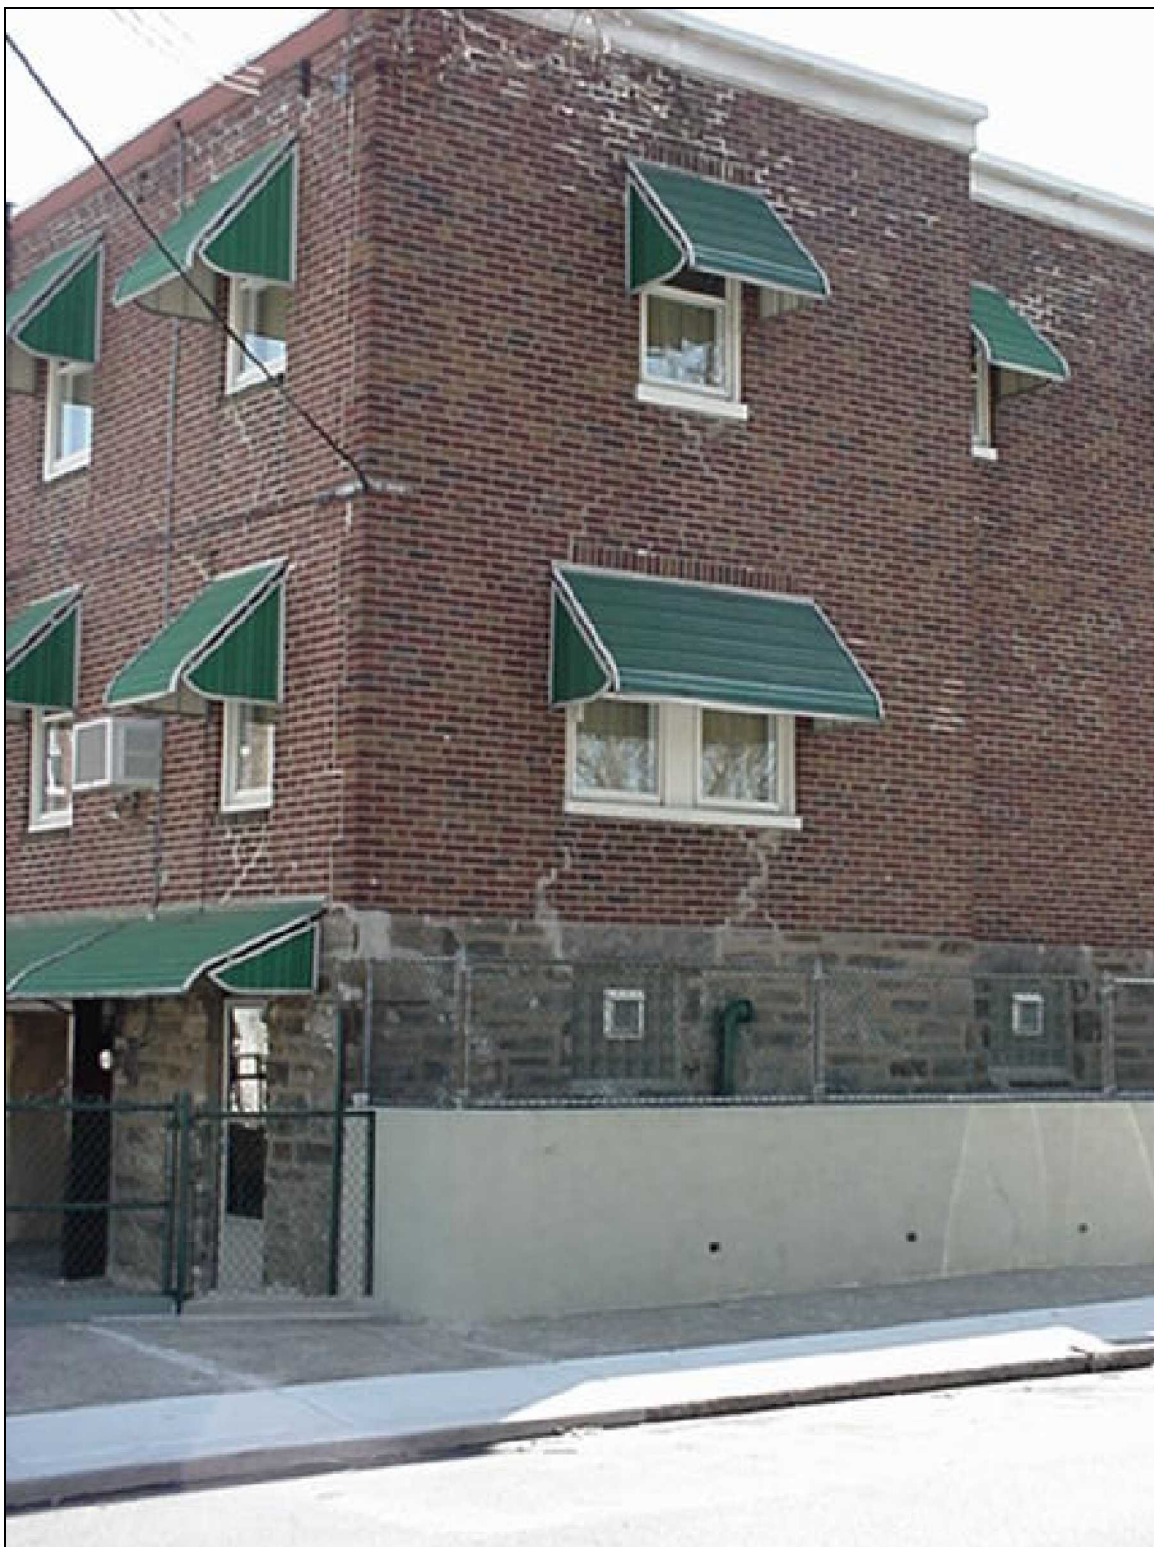
PHOTO #7. 4125 Levick St.-Rear and side of row home-Repaired step cracks from 1st and 2nd floor windows and from corner of structure through foundation wall on both sides of building.
